**SUBJ:** Fuselage – Cracking at Aft Tail Post Weld Joint on Piper Model PA-18 (L-21) Airplanes      **SAIB:** CE-13-14  
**Date:** February 6, 2013

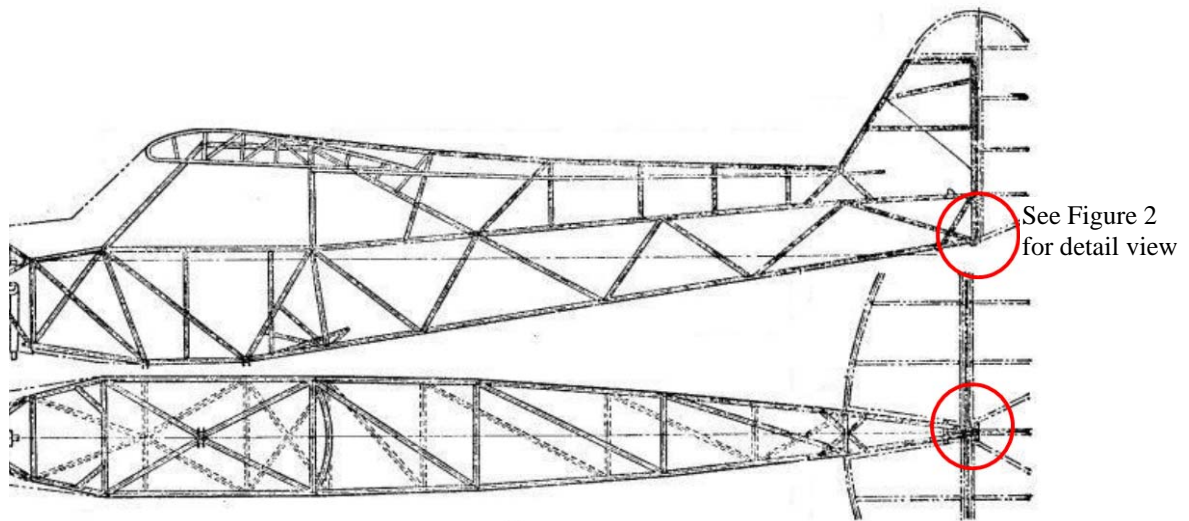
We received notice of this issue from a foreign operator. A Piper Model L-21B (PA18-135) airplane fuselage was completely disassembled to replace the worn fabric fuselage covering. After removing the fabric covering, paint was removed from the fuselage frame in areas considered susceptible to high stress and at major weld joints. A fluorescent penetrant inspection (FPI) was done on all these areas. The FPI inspection revealed two cracks in the fuselage tail section protruding into the lower rudder attachment hinge area (see Figure 1). To determine the extent of cracks into the adjacent welds and tubing, additional x-ray inspection of the area was done. The x-ray inspection revealed that the cracks did protrude into the adjacent weld areas (see Figure 2).

If undetected, these conditions could eventually lead to significant cracking and / or corrosion of the fuselage tube structure and result in a potential safety of flight hazard such as loss of control of the lower rudder hinge or tail wheel.

Figure 1 – Aircraft-level view of damage area

The FAA recommends the Piper airplane models listed below that have accumulated 1,000 hours total TIS be inspected within the next 100 hours TIS in the fuselage tail post area. We recommend use of an inspection method such as fluorescent penetrant and / or x-ray. Additionally, we recommend repeating the inspection every 1,000 hours TIS. These inspections are particularly important if the aircraft is subject to operation in severe turbulence, towing, or on rough terrain.

Repair or replace damaged components if you find cracks or corrosion

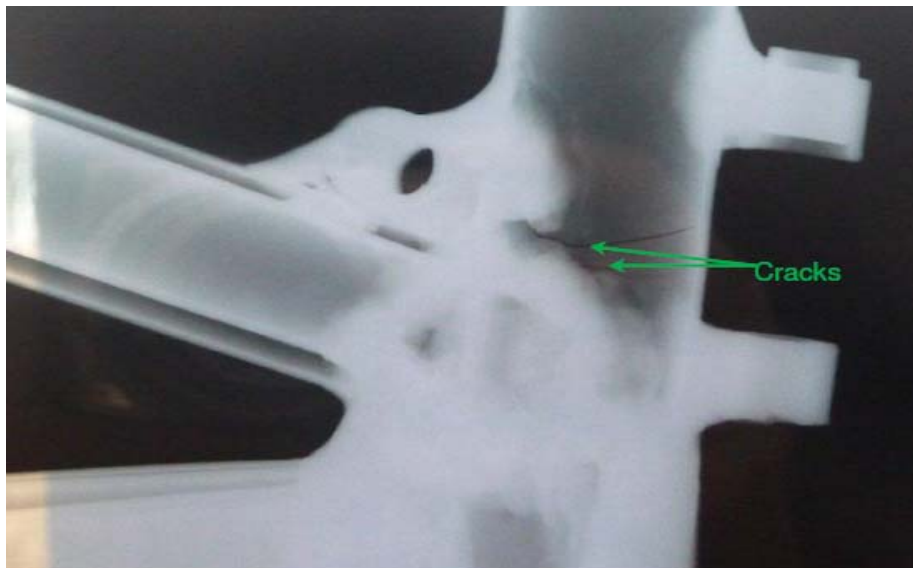
Figure 2 – Detail view of tail joint damage area
